Technical Report ARWSB-TR-17011

THE COMBINED EFFECTS OF STRESS CONCENTRATION AND TENSILE STRESSES FROM AUTOFRETTAGE ON THE LIFE OF PRESSURE VESSELS

Benét Laboratories

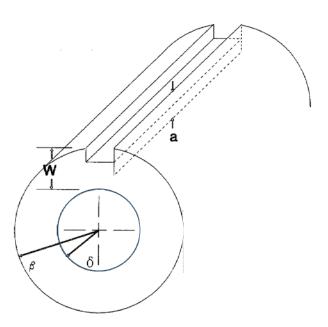
Figure 5 – Schematic of through wall cracking in an OD keyway during production of a thick walled pressure vessel.

In August 1990 and unanticipated failure of a pressure vessel occurred during the final stages of production of a pressure vessel when a 1.7m long through wall crack grew from an outside diameter keyway as sh schematically in Figure 5. As is common of pressure vessels of this type, which are filled with aggressive hydrogen gas during their lifetime, a passive chromium barrier coating is applied to the bore of the vessel in order to prolong service life and minimize the effects from exposure to these gases. However the process of applying the chromium coating is in and of itself very aggressive in that it exposes the underling high strength, highly susceptible Cr-Mo-V steel to concentrated sulfuric and phosphoric acids, at elevated temperatures, during its application. Because the chrome depositions were uneven on this particular vessel, it was subjected to a sodium hydroxide stripping bath in order to remove the uneven chrome and prepare it for a second chrome plating. After uneven chrome was observed after the second application it was once again exposed to a second sodium hydroxide stripping operation. It was subsequent to this second stripping operation that the cracking was observed.

This vessel prior to plating had been 100% overstrained in this region with an estimated hoop tensile residual stress on the outside diameter of the vessel of +578 MPa. The keyway configuration was such that the K_t was approximate 6.0, which resulted in the effective residual tensile stress in the root of the key way well above the 1200 MPa material yield strength.

Forensics examination of the fracture surface revealed two distinct region of corrosion covered intergranular crack extension believed to be the result of each Cr plating and stripping operation, followed by a third region with minimal corrosion, believed to be the final rapid crack advancement.

The mechanism of the unanticipated failure was the absorption of bulk hydrogen during exposure to the acid environments, migrating from the bore to the outside surface during the various plating operations, coupled with the localized tensile residual stress field from the autofrettage process in the keyway. It was speculated the thermal shock from subjecting to the room temperature pressure vessel to the elevated plating bath temperatures was significant enough to break any formation of protective oxide film at the outer surface thereby allowing fresh clean material to be continually exposed to aggressive hydrogen. Also, the process of application of Cr plating takes a considerable length of time. This exposure time is typically controlled in order to minimize any detrimental effect of bulk hydrogen absorption. Subsequent to proper plating, pressure vessels go through a low temperature thermal heating process to allow the minimal amounts of hydrogen trapped within the steel to escape. In this case no thermal processes were undertaken and as a result the hydrogen was allowed ample time to seek out the susceptible tensile residual stress field in the keyway.

Corrective recommendations made were to include a low temperature thermal bake out process subsequent to all Cr

plating operations, including those that need to be stripped for any reason. Also configurational changes were made in order to reduce the stress concentration effects of the keyway from K_t =6.0 to K_t =2.1, thereby reducing the effective stresses in the root of the key way by 3 times.
